Gold King Mine

Silverton, San Juan County, Colorado

0001/1408-01

PHOTOGRAPH LOG

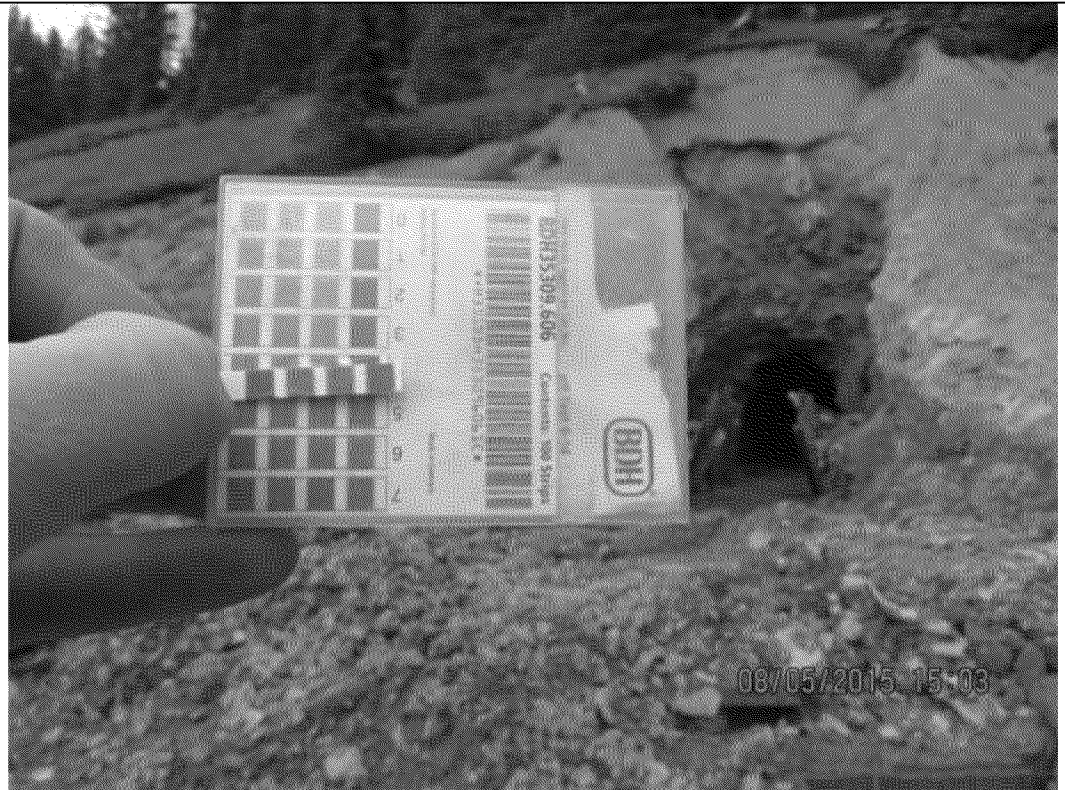
Photo No.
49

pH measured at approximately 4.5.
